LOAD SHIFT LOAD RESTRAINT GUIDANCE NOT ADHERED TO

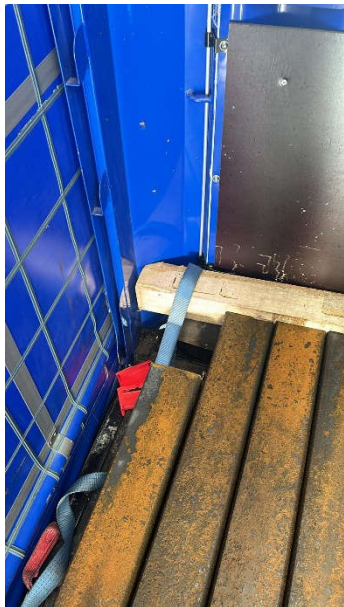
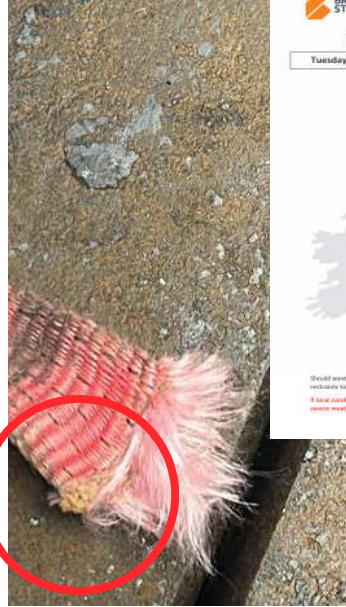
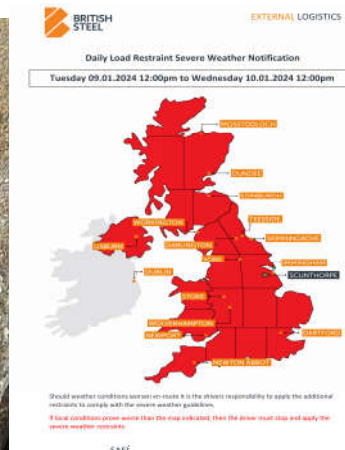
What's happened: After loading a driver has left site and after approximately 1 mile, at a roundabout, a 3rd party vehicle has cut across the truck causing the driver to brake heavily. Billets have moved forward breaking the false headboard and moving up to the trailer headboard. One headboard strap parted. Driver returned to site to have load readjusted and then continued his journey. Winter Weather bulletin advised extra ASM be used between product and base timber.

False Headboard arrangement not fully compliant – Anti-slip matting not applied underneath the short longitudinal timbers that support the longer transverse timbers. Evidence that one of the straps pulling back the false headboard timbers was badly worn. Winter Weather Bulletin not seen so extra ASM not used on top of base timbers.

- ✓ Always follow the Load Restraint Guidance (LRG) where issued.
- ✓ Ensure Anti-slip Matting is placed as per the LRG.
- ✓ Always Check with Sites if Winter Weather Restraint is needed **before loading.**
- ✓ Never use substandard equipment – if in doubt replace with new.

✓ Always take photos once load is secured to confirm how the load left site,

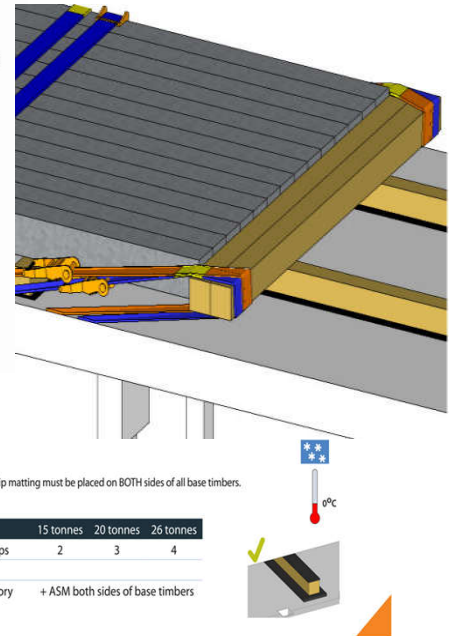
5. Winter weather advisory periods

During winter weather advisory periods, anti-slip matting must be placed on BOTH sides of all base timbers.

Load	15 tonnes	20 tonnes	26 tonnes
Forwards blocking + Opposing loops	2	3	4

During severe winter weather advisory periods + ASM both sides of base timbers
