NEAR MISS ROOF SUPPORT FAILURE

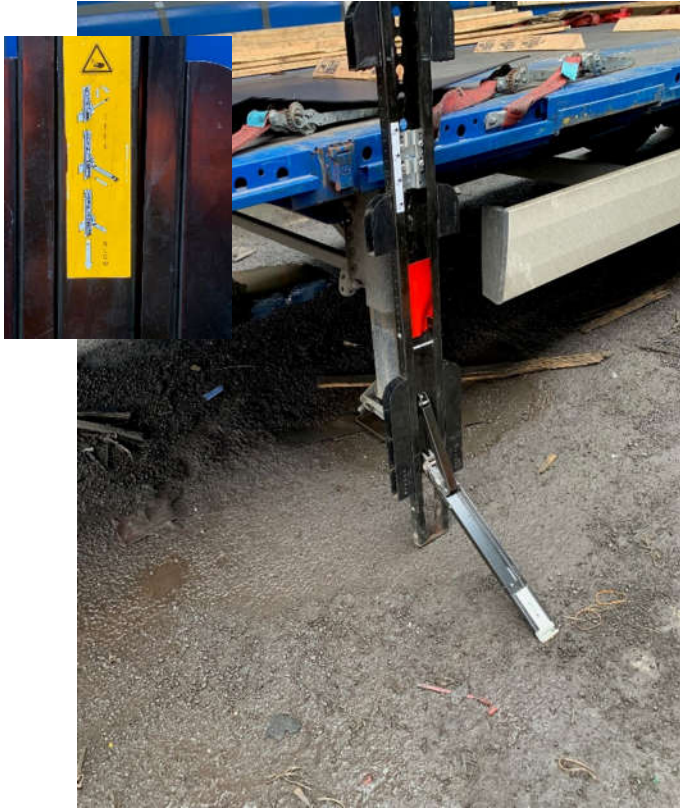
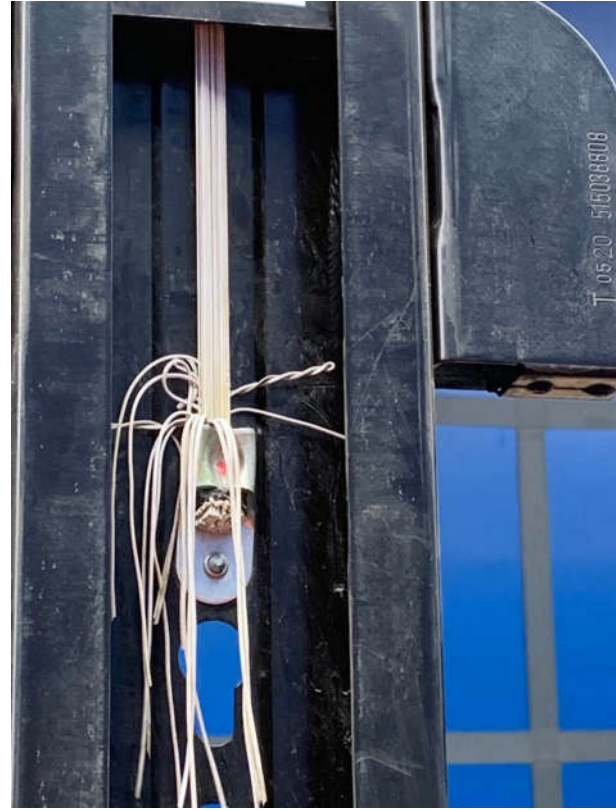
What Happened - As Shunter was preparing a Mega type trailer for loading, as the near side front roof support was released the inner telescopic sleeve as fallen to the floor narrowly missing his foot.

Findings – Internal Tension Cable severely overstretched.

Drivers must Check:-

- ✓ Is my equipment in a good condition?
- ✓ Are the roof supports in good working order?
- ✓ Ensure you are familiar with roof supports and their release method as these can vary between different trailer manufacturers.
- ✓ Always stand to one side in case of sudden release.
- ✓ Report any defects with truck and trailers to your office
