REARWARDS TOPPLED SLIT COILS

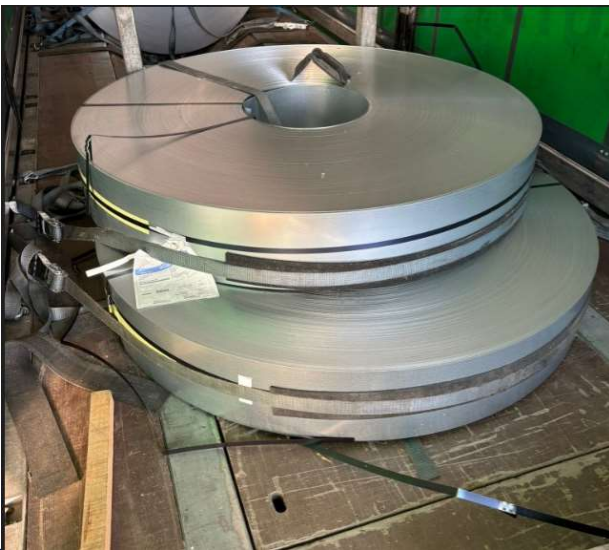
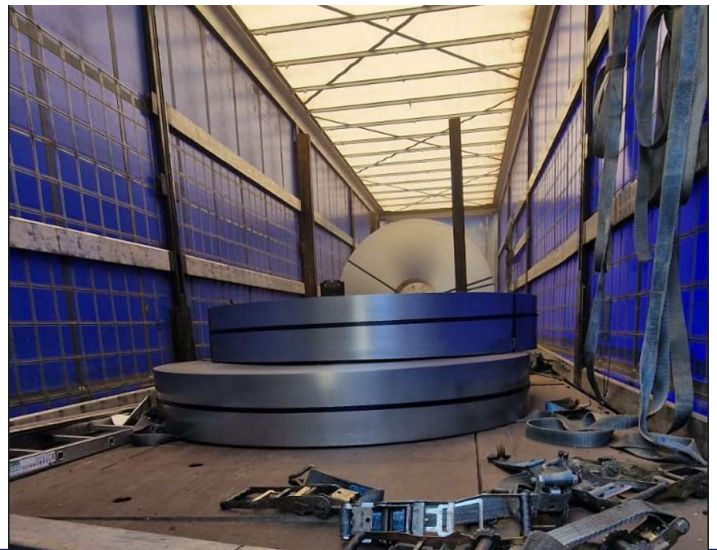
Recently 2 incidents occurred with slit coils in the coil well toppling backwards in transport.

The coils were not adequately secured as per Tata Steel TAD (Technical Advice Document).

Loads were not secured as per (TAD – Technical Advice Document) TAD-0074 Narrow Coil in well.

- ✓ Please share “TAD-0074 Narrow Coil in Well” document to drivers collecting slit coils in Maastricht.

- ✓ Drivers collecting slit coils may only leave the loading location after approval by surveyor.
