PARTIAL LOAD LOSS

What Happened – As Driver was transiting from the trailer park to the Live Load area, to get assistance with strapping his load, as he has turned out of the Trailer Park 2 road to enter Trailer Park 1 the near side gun-barrel coil has fallen/ rolled off the trailer to the ground and been severely damaged.

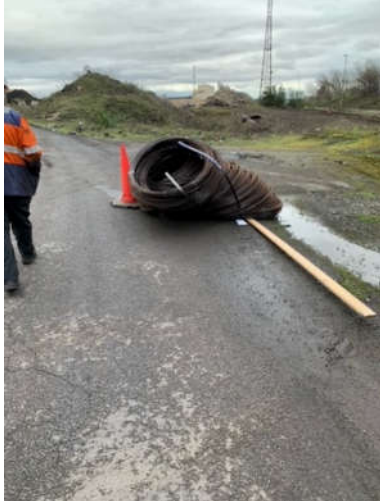
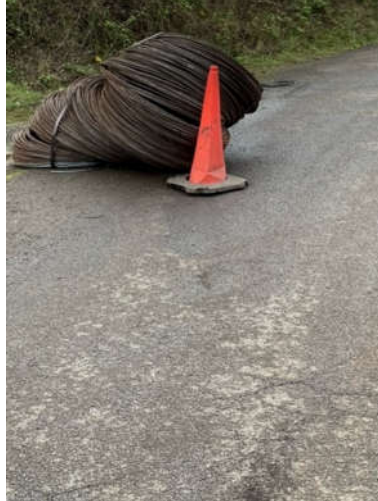
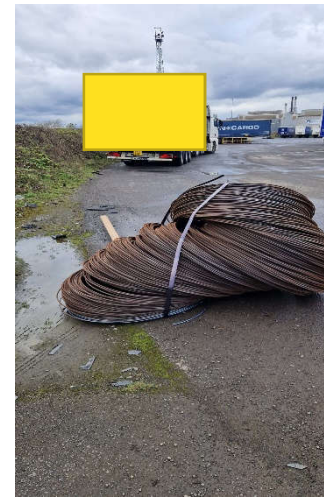
Driver claimed he had checked the load and a piece of wood was missing? No evidence taken to support this.

Driver had not applied any straps on the load at all for the transit to Live Load area, which would have prevented the coil moving.

Driver did not close the curtain before transiting which may have stopped the coil falling from the trailer.

- ✓ Drivers **MUST Book IN** before going to the Trailer Parks. (As per attached).
- ✓ Is the load configuration correct? If not take a photo and **REPORT IT! DO NOT MOVE UNTIL CORRECTED!**
- ✓ **ALL** Loads **MUST BE Strapped in the Trailer Park** as per instructions attached.
- ✓ **NEVER** Transit anywhere without applying straps. To assist placing of shunt straps **BOTH curtains MUST BE prepared** for the loading (As per attached).
- ✓ **Always** close trailer curtains before transiting between sites.

Report any issues directly with the Dispatch Office on site.
